Volume 3

Melbourne Airport
M3R MDP

Chapters B6–B9

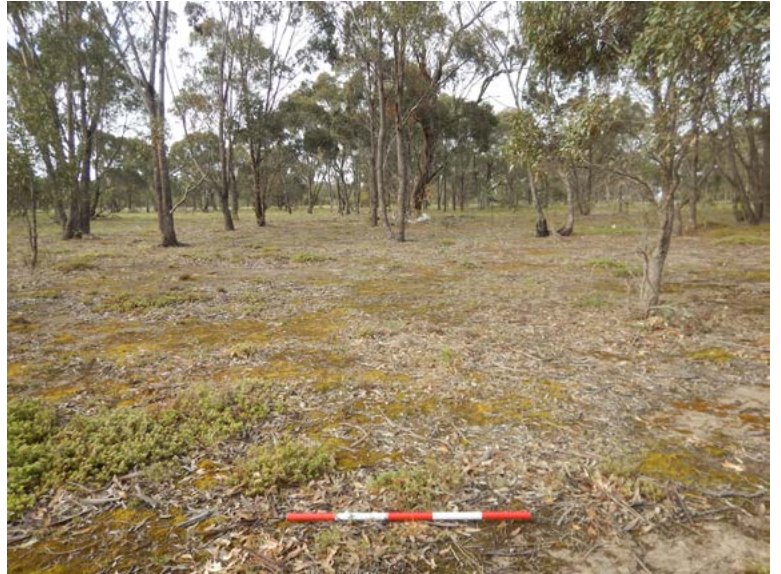
Figure B6.7
Eroded crest of the granite hill facing
south-east showing sample
of identified surface artefacts
(pink flags) (K.White 12/11/19)

Test pit 1 recorded a profile of coarse silt and highly degraded rock structure (to 50 per cent deposit) with some degraded granite throughout. This was excavated to the depth of undulating granite rock between 300mm to 320mm. Eighteen stone artefacts were recorded within the upper 200mm of the pit, thereby demonstrating some potential for artefacts to be present below ground surface. Subsequently, test pit 2 was excavated at an open area to the east, and just below the elevation of the crest. Test pit 2 is approximately 80 metres east of test pit 1 and recorded a consistent

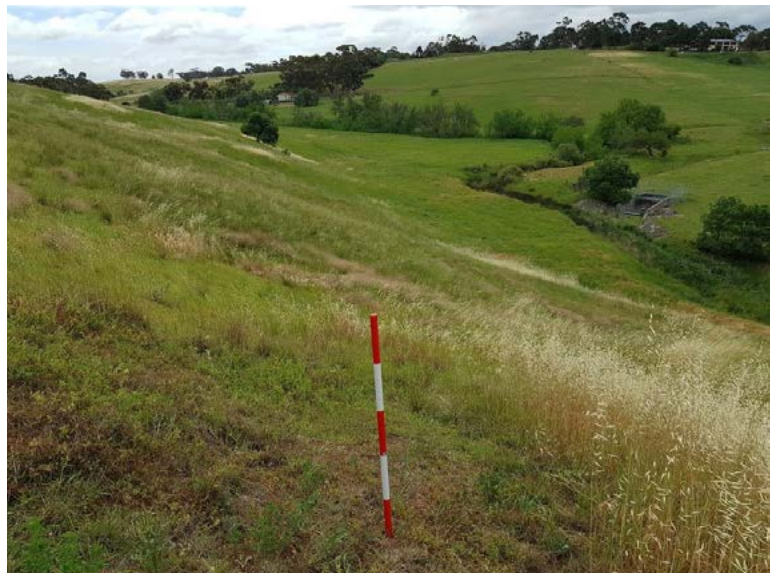
Figure B6.8
View north from southern end of
activity area over hillslopes and
floodplains of the Arundel Creek
corridor (E.Nuridin 6/11/19)

The southern part of the study area comprises undeveloped land either side of Arundel Creek (Figure B6.8). Parts of the hillslopes, particularly above the west bank, appear subject to prior disturbances and are now eroding. Most of the area is covered by agricultural grasses, although impacts of prior land modifications were noted. These included the reshaping of the creek line, possible deposition of alluvial sediments on the floodplain area, and subsequent modern infrastructure. A number of isolated surface artefacts were identified but, due to their isolated recording, are likely to represent the displacement of material in the immediate landscape rather than a dense concentration in the area of recording.

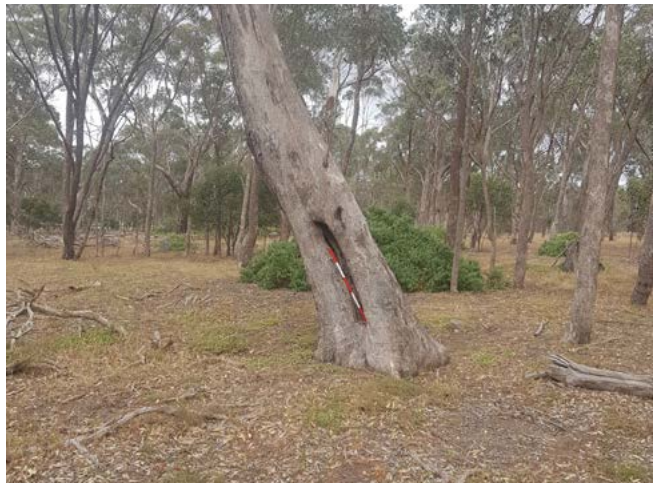
Figure B6.36
Relocated scarred tree
VAHR 7822-0802
(Radar Hill 3) view of
scar side looking south

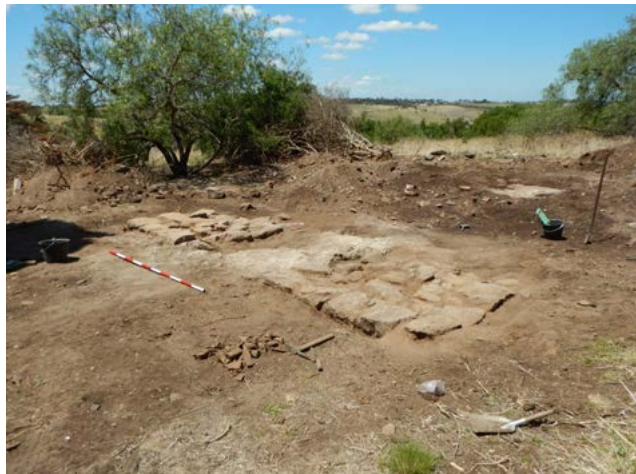
Figure B7.11
Barbiston Farm foundations following excavation

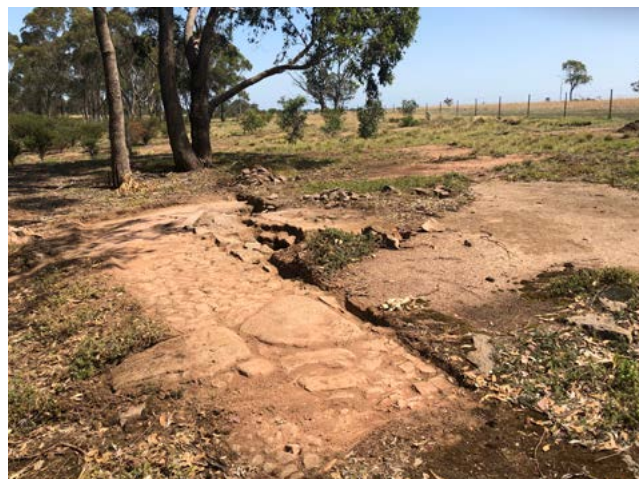
Images **Figure B7.14**
Kennedy's Hut site during initial excavation looking over threshold and exterior paving, facing south-west, 2020

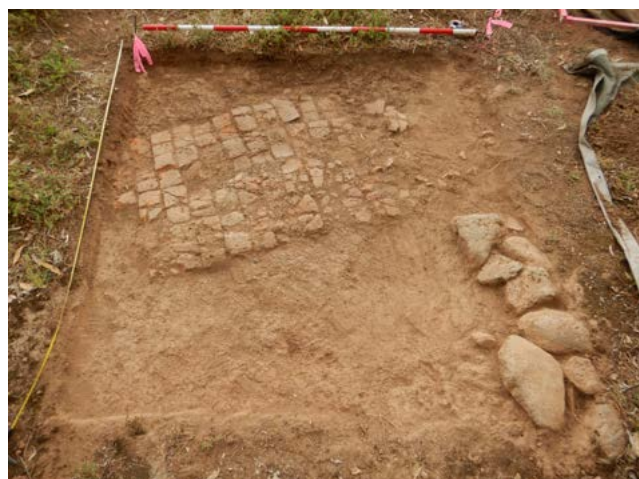
Figure B7.15
Detail of brick paving at rear of Kennedy's Hut site, 2020

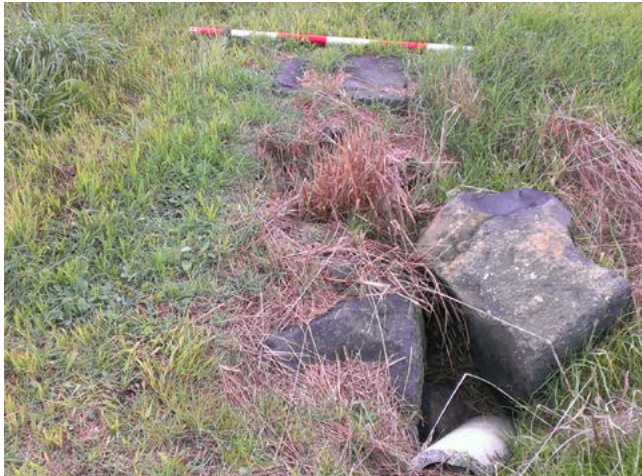
Condition	Fair
Images	<p>Figure B7.21 Bluestone culvert, looking south, 2016</p>

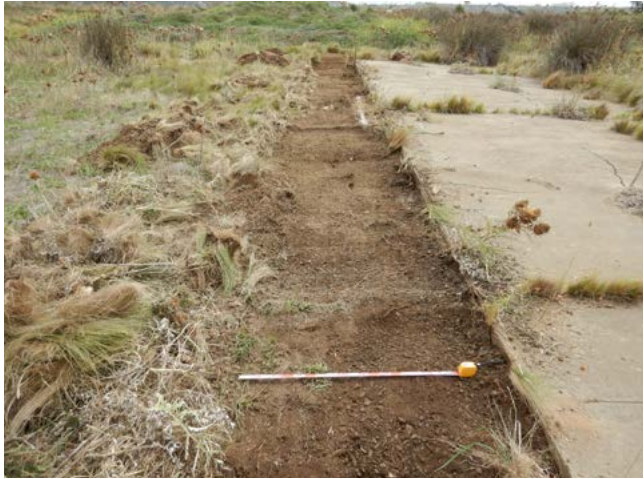
Condition	No significant archaeology
Images	<p>Figure B7.23 Example of ground stripping below modern concrete slab construction during investigations 2020</p>

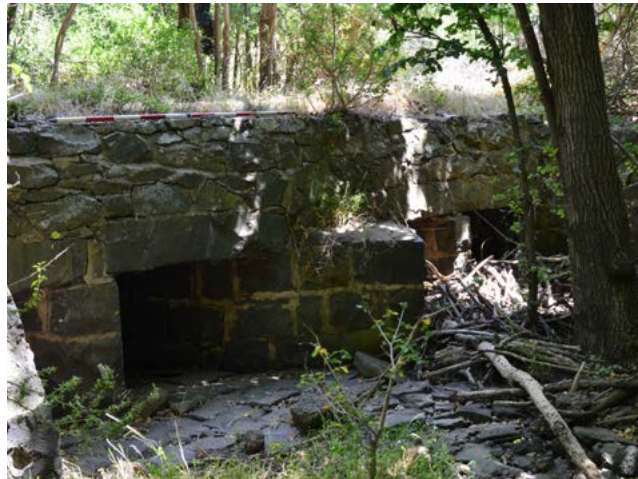
Description	<p>The Grants Road culvert is a four-cell box culvert constructed entirely of bluestone with long stone lintels over dwarf walls and a stone paved base. Angled cutwaters extend on the upstream side with wing walls either end. Stone-lined drains direct water from two separate channels. The downstream face of the culvert has failed with wing walls, piers and lintels having fallen into the waterway. The surrounding land is covered in a dense copse of elm trees, which appear to have spread from a small number of now dead or senescent trees planted as an avenue either side of the crossing.</p>
Condition	Although the culvert has failed in some sections, the culvert is still in use.
Images	<p>Figure B7.27 North side of culvert showing cutwaters, 2013</p>

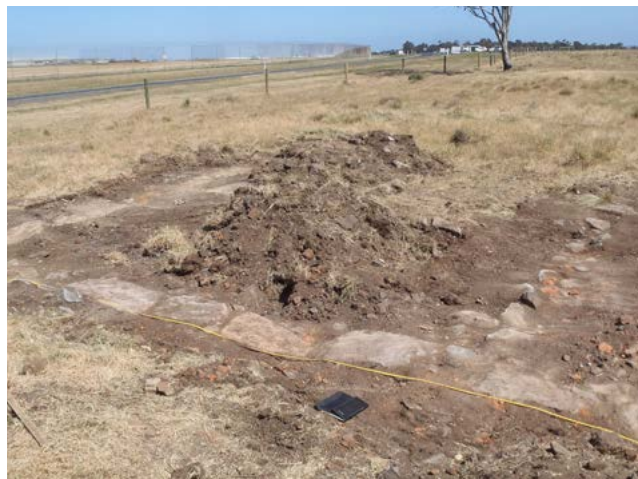
Figure B7.30
Foundations of Seafield Homestead following mechanical excavation, 2014
